## **1. INTRODUCTION**

### **1.1 Overview of Mir Photo/TV Survey**

STS-63 was the Shuttle's first rendezvous with the Mir station. Over 1000 photographs and 10 hours of video were acquired during the rendezvous. The Image Science & Analysis Group (IS & AG) initiated several analysis tasks using the returned imagery data based on user requirements. They were to:

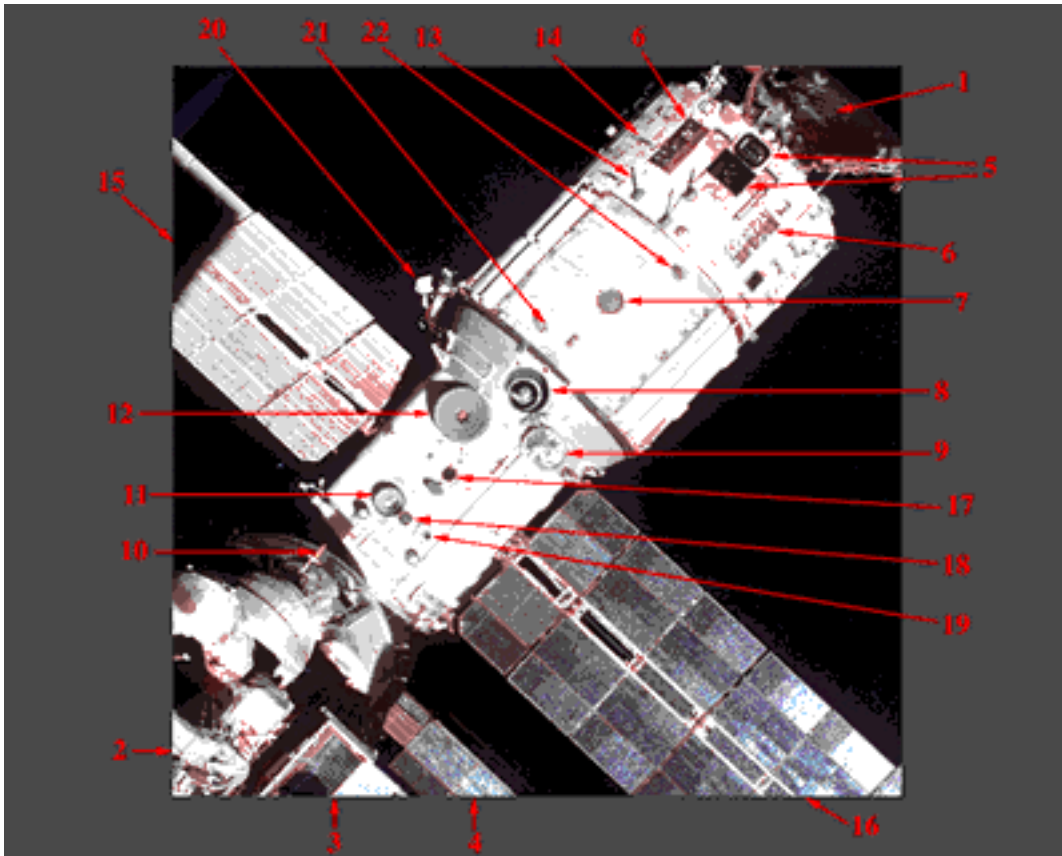
**Figure 2-D Mir Base Block / Kvant 1 Module / Kristall Module**

1. Kvant 1 Module
2. Kristall Module
3. Kristall Port Solar Array
4. Kvant 2 Starboard Solar Array (Kvant 2 is located below Kristall)
5. Attitude Control Thrusters
6. Micrometeoroid Sensor
7. Airlock Hatch Cover
8. Earth Observation Window
9. Window Cover With Flexible Metallic Surface
10. Approach and Rendezvous (Igla) Antenna
11. Window Blind
12. Observation Window Blind
13. Radio/Telemetry Communications Antennas
14. EVA Handrails
15. Mir Port Solar Array
16. Mir Starboard Array
17. Window with Cover
18. Cosmonaut's Wide-angle Sight
19. Instrument for orientation on eclipsed orbital sections
20. Cargo Boom Base
21. Television Antenna
22. Flashing Light

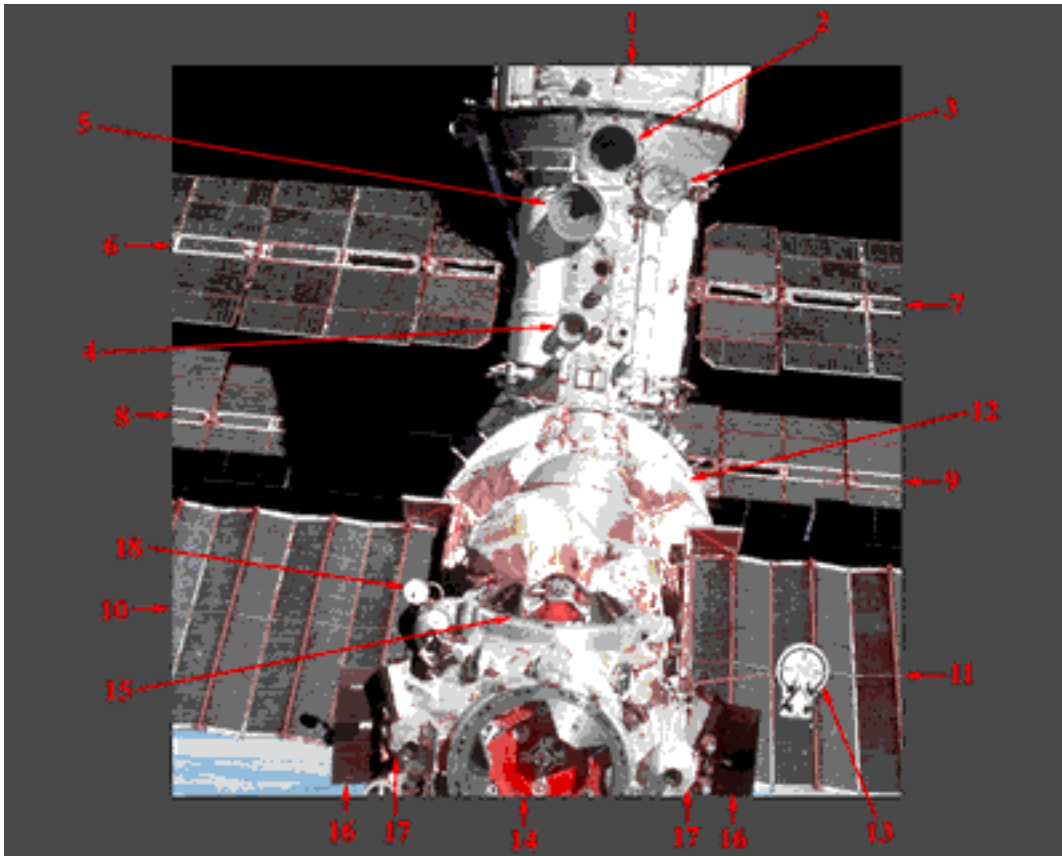
**Figure 2-E Kristall Module / Mir Base Module**

The solar arrays of the Base block, Kvant 2, and Kristall are all visible in this image.

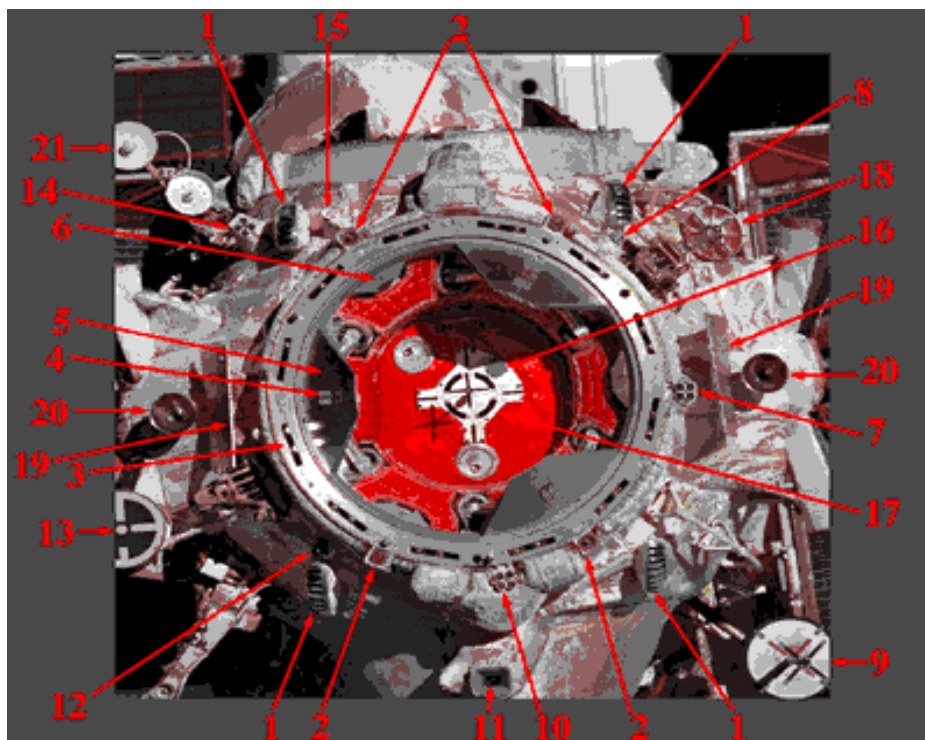
**Figure 2-F Kristall Docking Mechanism**

This is the docking port which will be used on STS-71 to connect to the Mir Complex. Discrepancies between this photograph and available diagrams of the docking unit are described in section 2.2.

Photography of the Kristall Docking Mechanism (see Figure 2-F) shows four connectors visible around the circumference of the docking frame. Both the diagram in NASA Document # WG-3/NPO E/NASA/002/3402 0 and the NASA Document “A Russian Space Station: The Mir Complex”, show eight connectors around the circumference of the docking frame. The latter describes the connectors as: Fluid Connector Socket (2), Electrical Connector Plug (2), Electrical Connector Socket (2), and Fluid Connector Plug (2). Discussions with the Payload Integration and Engineering Office (MS2) indicate that this is not an issue for the STS-71 docking.

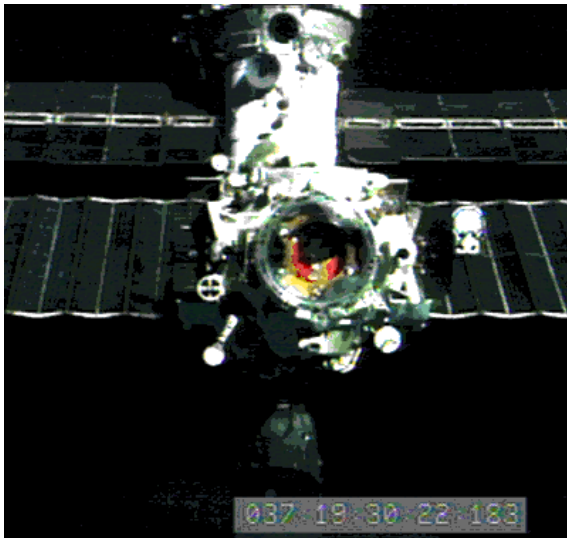
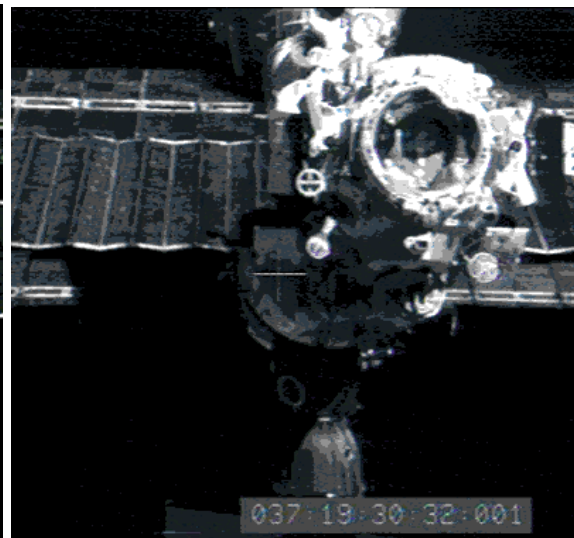
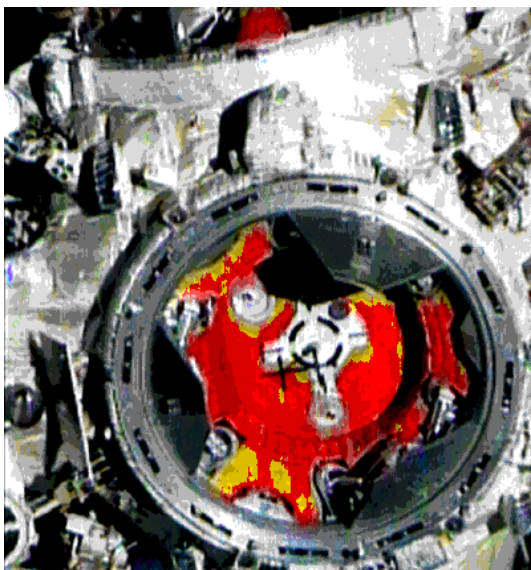
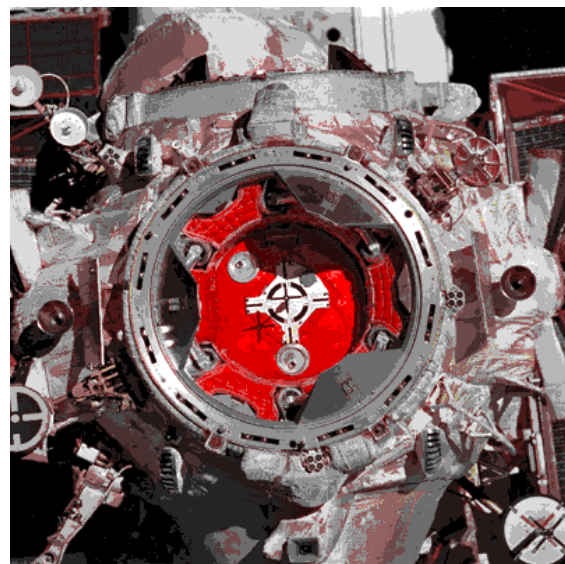
**Figure 4-A Target Visibility Comparison**

Figure 4-A documents views of the target from the MLA, the CTVC and the handheld camcorder. All pictures were taken at about the time of closest approach. However, lens and aperture or iris settings varied greatly. Therefore, direct comparisons of the different views are not possible.

The 70 mm photograph shows a level of detail presently only possible on film. The MLA and CTVC images did not reveal much detail inside the docking mechanism, especially where the target was in shadow. However, since their iris and zoom settings were not adjusted to maximize dynamic range and resolution characteristics, a fair evaluation of these two cameras can not be performed. The camcorder's ability to extract information even when the target is in shadow may be useful for viewing events which occur in low light level conditions.

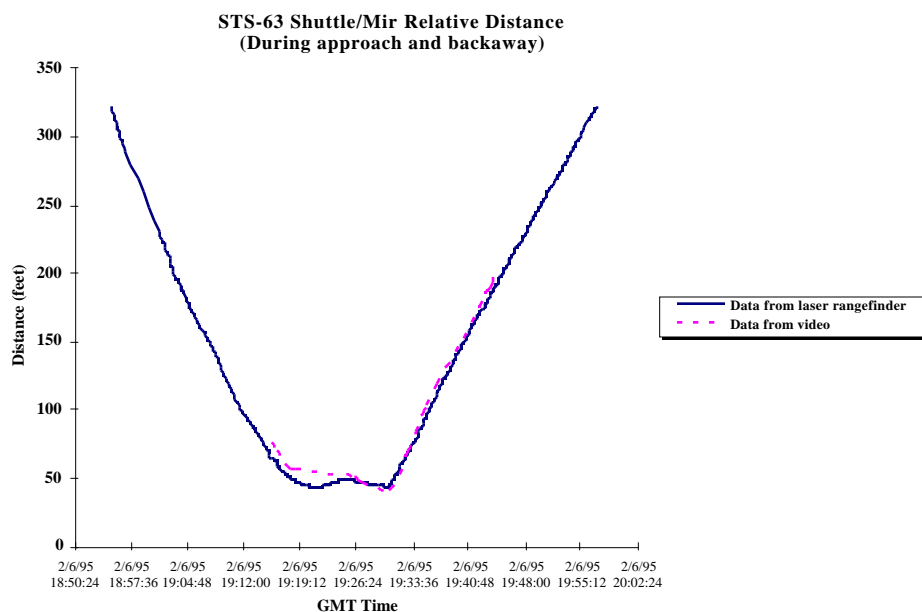
**Figure 6-A Shuttle/Mir Relative Distance During Approach and Backaway**

Figure 6-A compares actual TCS data with that from the CTVC centerline video camera. The CTVC camera distance calculations utilized horizontal-field-of-view information embedded in the vertical interval.

This chart shows that distance calculations based on CTVC camera data appeared to be consistent with the more accurate TCS data during the daylight portions of approach and backaway. However, no information could be gathered from these views during darkness. Fly-around data did not show sufficient detail to extract accurate scaling information.

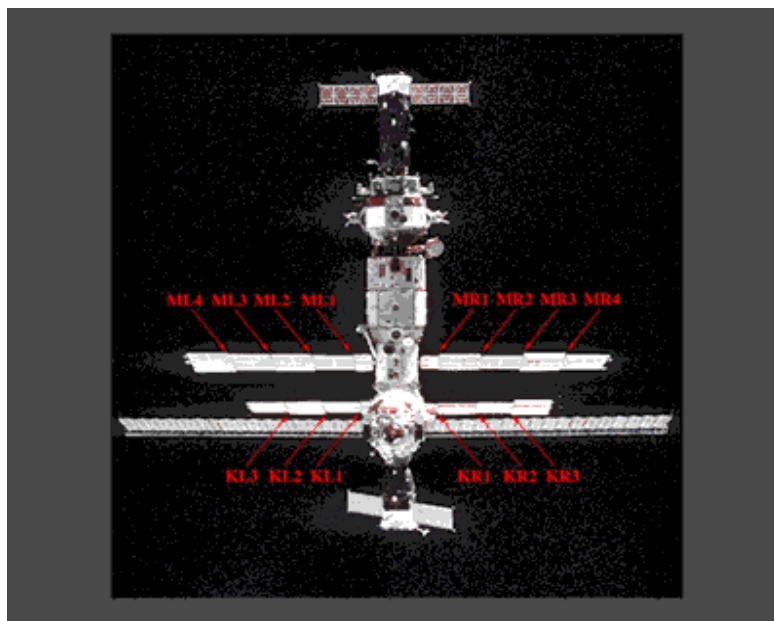
**Figure 8-A Solar Array Sub-panel Nomenclature**

Small offsets between sub-arrays were noted on some of the Mir solar panels. These deflections might have an impact on loads analysis when the Shuttle and Mir are in a docked configuration. Offset angles between consecutive sub-panels on the Core and Kvant-2 modules were measured from selected 70 mm film views. The diameter of the Mir Core module was used as a scale factor for all measurements.

Figure 8-A shows the different offset angles that were measured. The panels were assumed to have no bends in their structural supports. Sub-array panel offset angles are shown in the accompanying table:
